CORRIDOR REVIEW

WV 25 and WV 62

(Poca to North Charleston)

Regional Intergovernmental Council

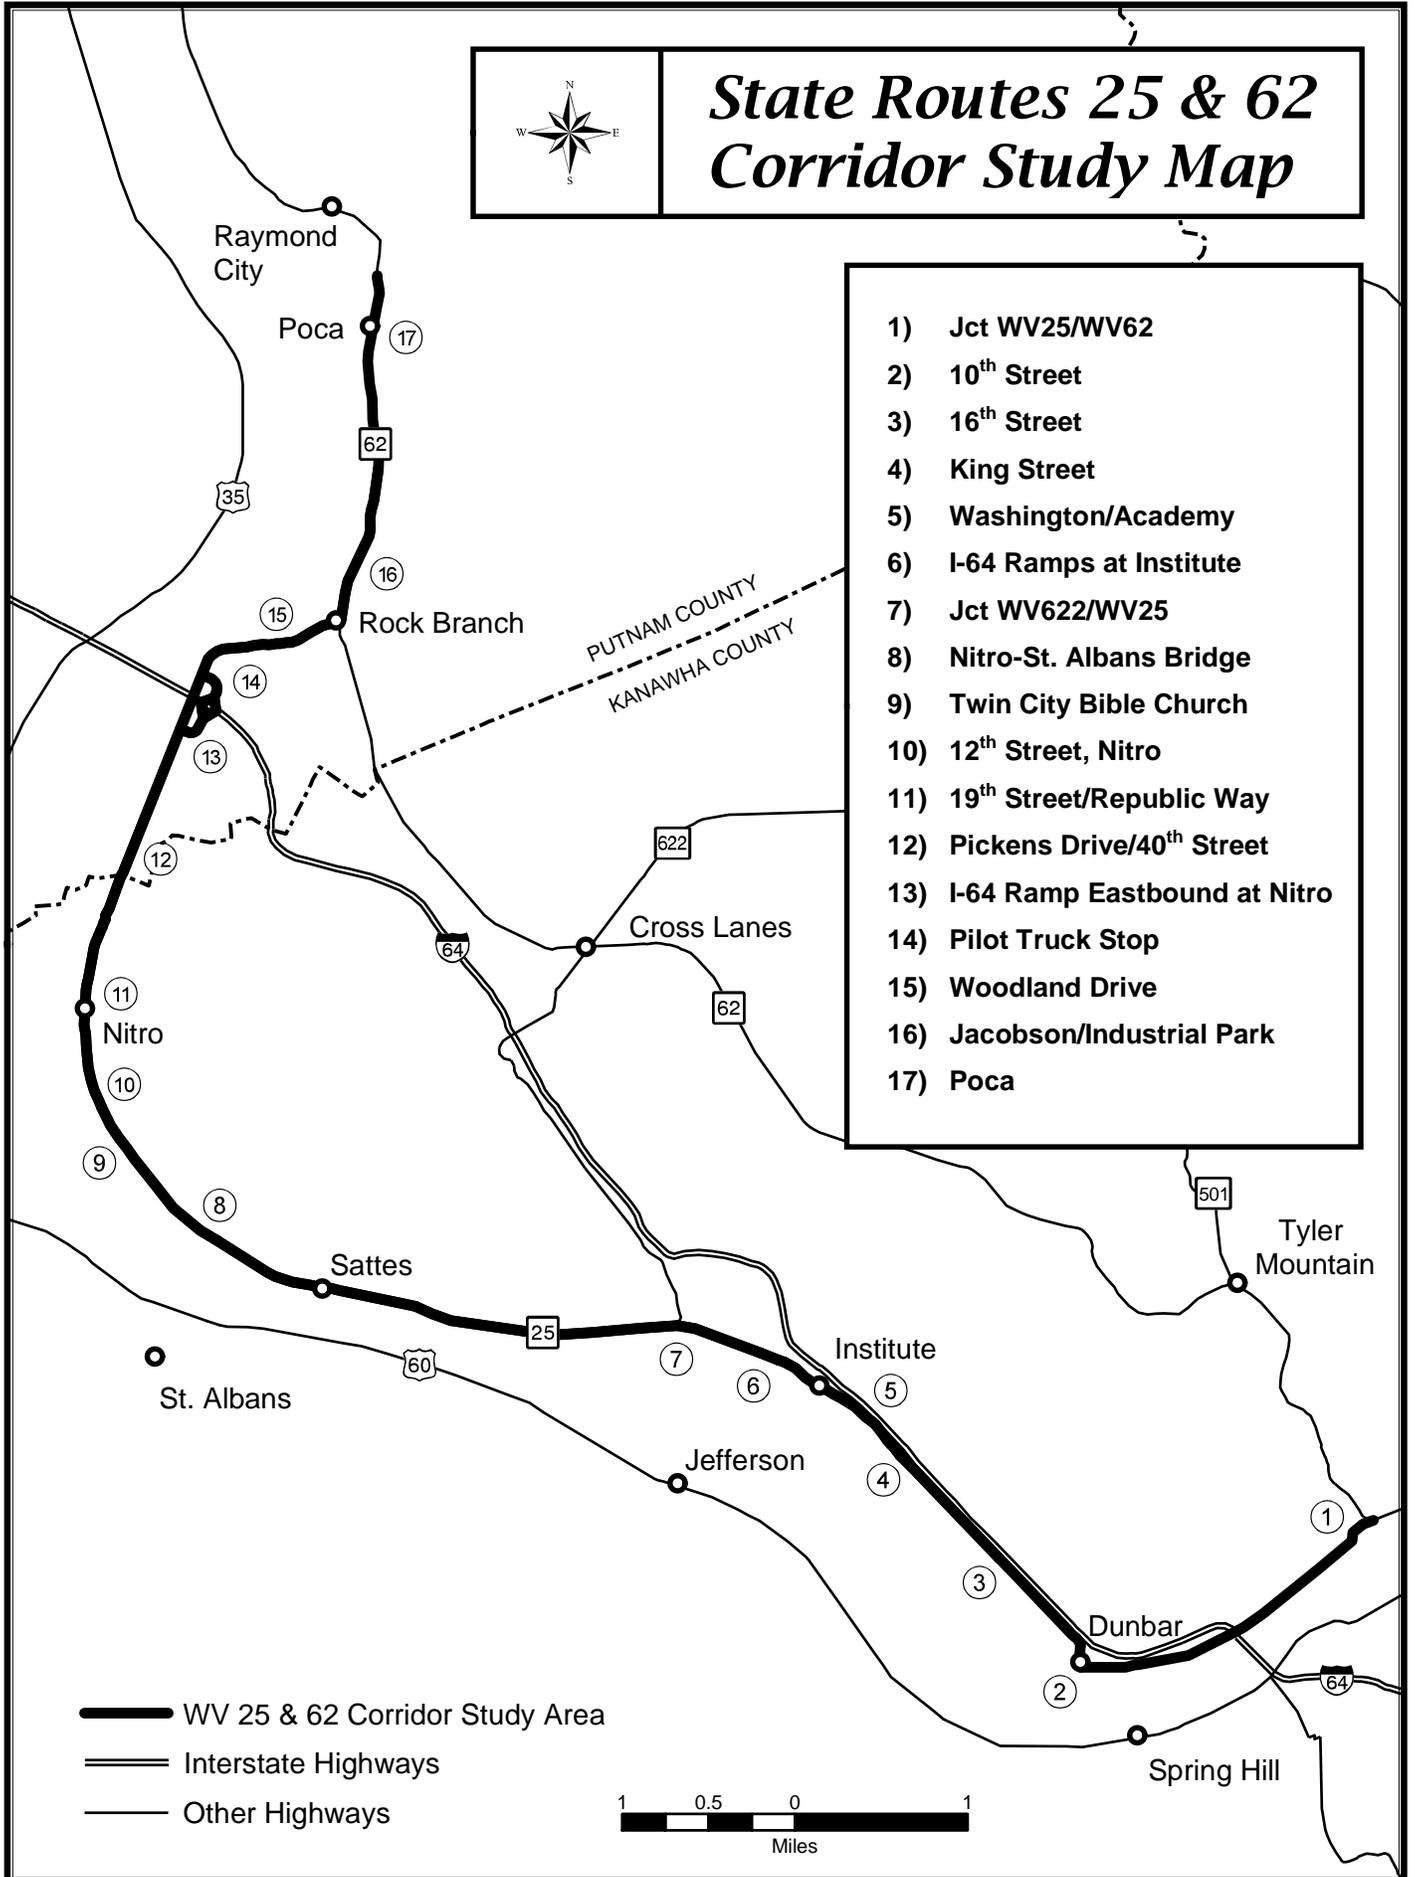
State Routes 25 & 62 Corridor Study Map

- 1) Jct WV25/WV62
- 2) 10th Street
- 3) 16th Street
- 4) King Street
- 5) Washington/Academy
- 6) I-64 Ramps at Institute
- 7) Jct WV622/WV25
- 8) Nitro-St. Albans Bridge
- 9) Twin City Bible Church
- 10) 12th Street, Nitro
- 11) 19th Street/Republic Way
- 12) Pickens Drive/40th Street
- 13) I-64 Ramp Eastbound at Nitro
- 14) Pilot Truck Stop
- 15) Woodland Drive
- 16) Jacobson/Industrial Park
- 17) Poca

- WV 25 & 62 Corridor Study Area
- Interstate Highways
- Other Highways

Following are the analyses and recommendations for all 17 selected sections.
