## Spring Hill Corridor Study – Executive Summary

The study area encompasses a 1.48 mile section of MacCorkle Avenue (US 60) in South Charleston from Rock Lake Drive (mp 9.69) to Jefferson Road (mp 11.17) and contains eight signalized intersections. Throughout this corridor of MacCorkle Avenue there are five lanes with intermittent on-street parking. This corridor was part of a larger corridor review completed in 1982; since that time there have been many changes in land use and intersection

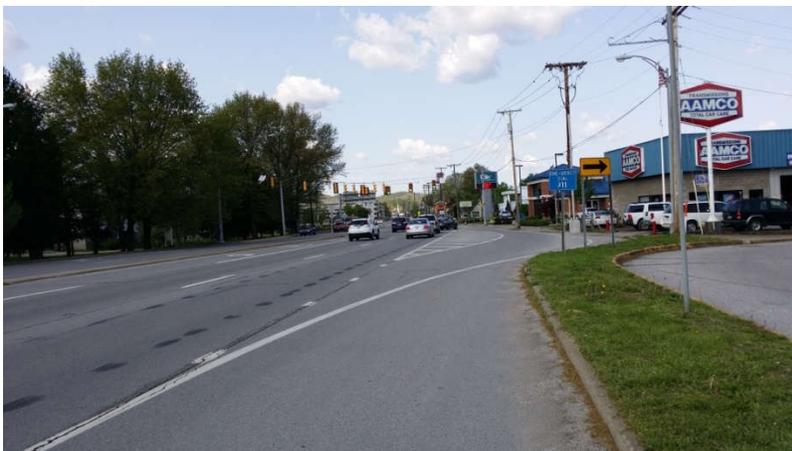
**Figure 1: Kenna and MacCorkle Ave.**

There are eight coordinated traffic signals through this corridor; traffic volume growth can affect the efficiency of a traffic signal. Signal optimization is one of the most cost-effective ways to improve traffic flow, and is recommended in this scenario. Throughout the corridor, lane width should be made consistent and pavement markings upgraded. Additionally, the existing on-street parking should be removed and the center turn lane made constant. With a consistent roadway width, existing right-of-way would allow for wider sidewalks or the addition of a bike lane. Along MacCorkle Avenue and several side streets, there are crumbling curbs and narrow sidewalks which need repaired. If these sidewalks were slightly widened and the utilities were relocated, the sidewalks would become wheelchair accessible. It is also recommended to alter the intersection of Kenna and MacCorkle Avenue to a standard plus intersection. Currently, the westbound approach on MacCorkle Avenue includes an old bus pull off, which is under-utilized. This unconventional right turn lane causes some drivers to overlook the turn lane and congest traffic in the slow lane while turning right; this was evidenced during field reviews.

- Signal Optimization
- Consistent traveling lane width.
- Repurpose on-street parking for wider sidewalks or extension of bike lane.
- Make center turn lane consistent throughout corridor.
- Relocate utilities or take necessary steps to follow ADA accessibility guidelines in sidewalk construction.
- Correct intersection of Kenna and MacCorkle Ave.

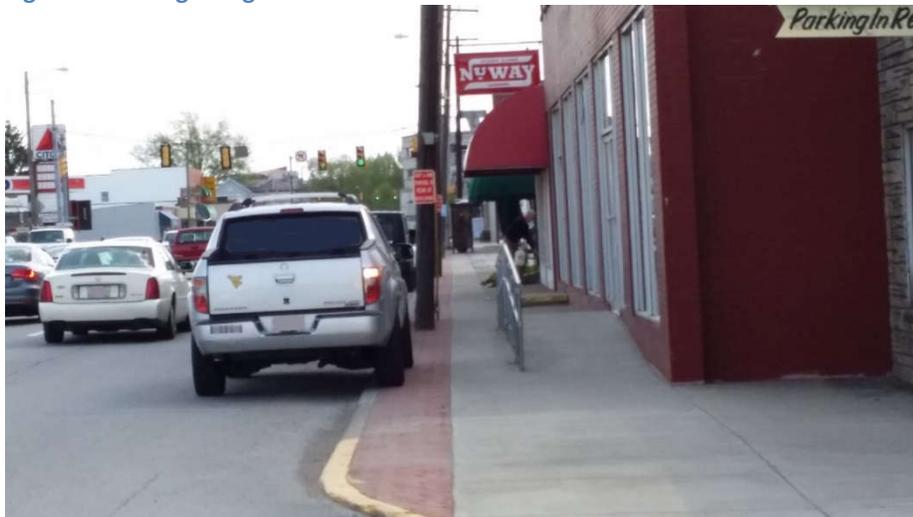
**Figure 2: Parking along MacCorkle Ave.**

Currently, the left (or fast) lane remains a constant width while the right (or slow) lane varies. On-street parking is also inconsistent and lacks proper signage and pavement markings. Inadequate signage allows for on-street parking in places where there is insufficient space; this creates at the best a delay in traffic and at the worst a collision. As evident in Figure 2, there is not adequate parking space along MacCorkle Avenue, causing cars to park on the sidewalk which impedes pedestrian flow and damages the sidewalk. As noted in the Crash Analysis for the intersection of Chestnut Street and MacCorkle Ave, sideswipe accidents have remained constant over time where on-street parking occurs; yet the overall accident rate has decreased. This suggests overall roadway safety is increasing while on-street parking is resulting in sideswipe collisions.
